THE DEMOLITION OF A 130,000 CUBIC METRE TANK'S FLOATING ROOF.

THE TECHNICAL METHODS AND COMBINED SKILLS USED IN THIS DEMOLITION AND RECLAMATION PROJECT RESULTED IN THE COMPLETION OF A LARGE-SCALE OPERATION, GUARANTEEING HIGH STANDARDS OF **SAFETY AND ENVIRONMENTAL PROTECTION**

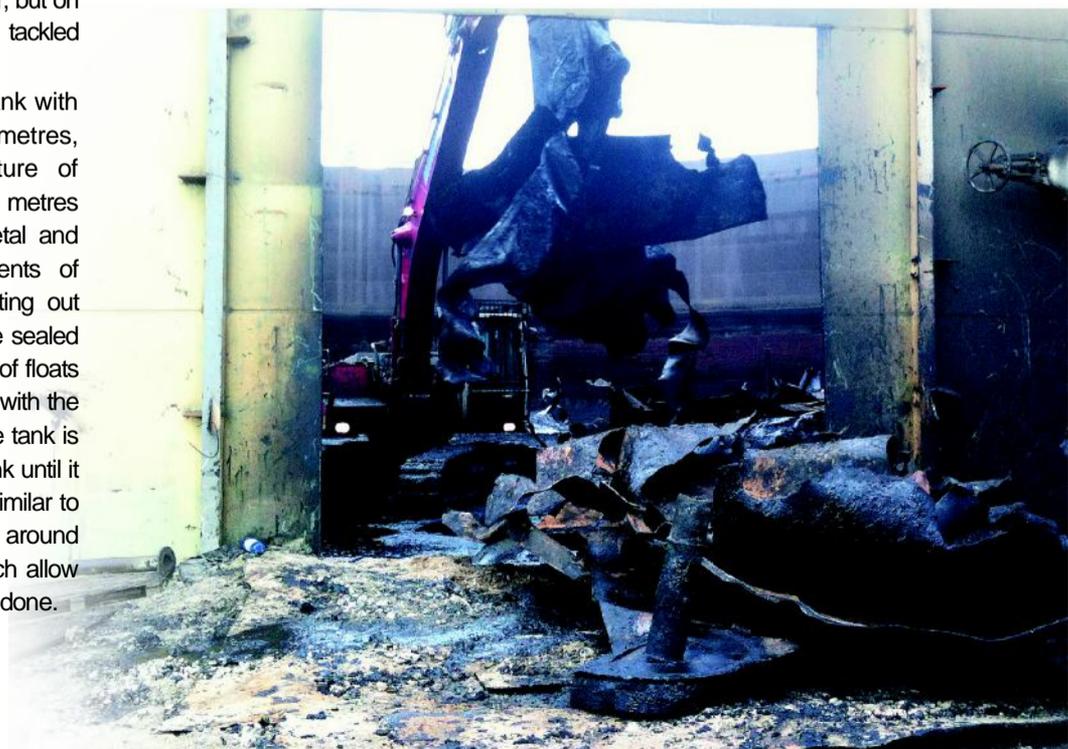
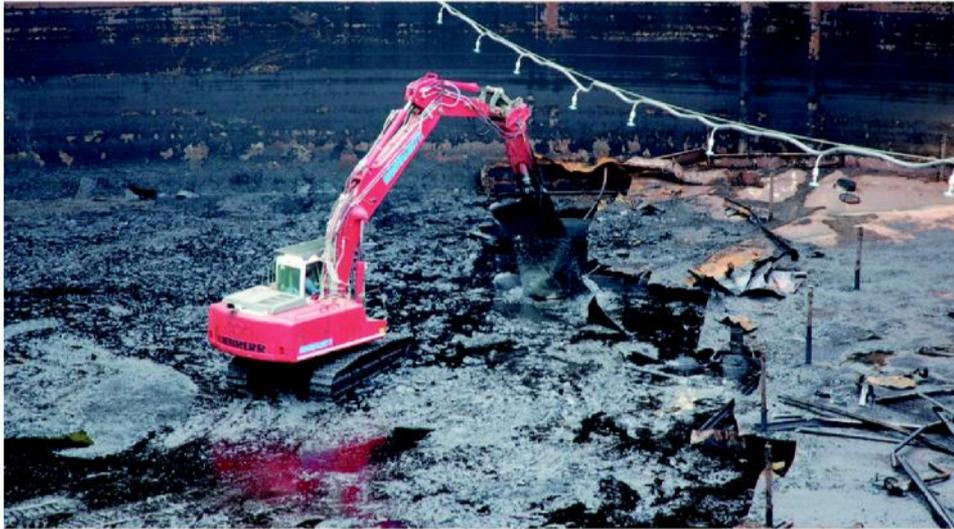
The tank in question had originally been designed to hold crude oil, but during its working life it had been 'downgraded' and was used to contain slop and bilge residues. During our inspection of the site, we immediately ascertained that due to the highly corrosive properties of the materials contained inside (especially crude oil with high levels of

sulphur), many compartments had lost their watertight properties and liquid had seeped inside. When the tank was emptied, the floating roof, weighed down by the

liquid in the compartments, had become

unbalanced. Once the support legs reached the bottom, they crippled under the excessive weight. As the roof collapsed from the pressure below, it had practically come to rest on the floor of the tank.

The situation we witnessed was that of a structure whose existing conditions would not allow access, in that the floating roof had been classified as dangerous due to the precarious state of the sheet metal and the supports.

No reclamation work would be possible in these conditions without demolishing the floating roof first.

It was necessary to demolish the roof so as to allow access both to the contaminated compartments as well as the gap, only a few centimetres wide, between the bottom of the tank and the floating roof, in order to remove residual material and clean the floor and sides of the tank.

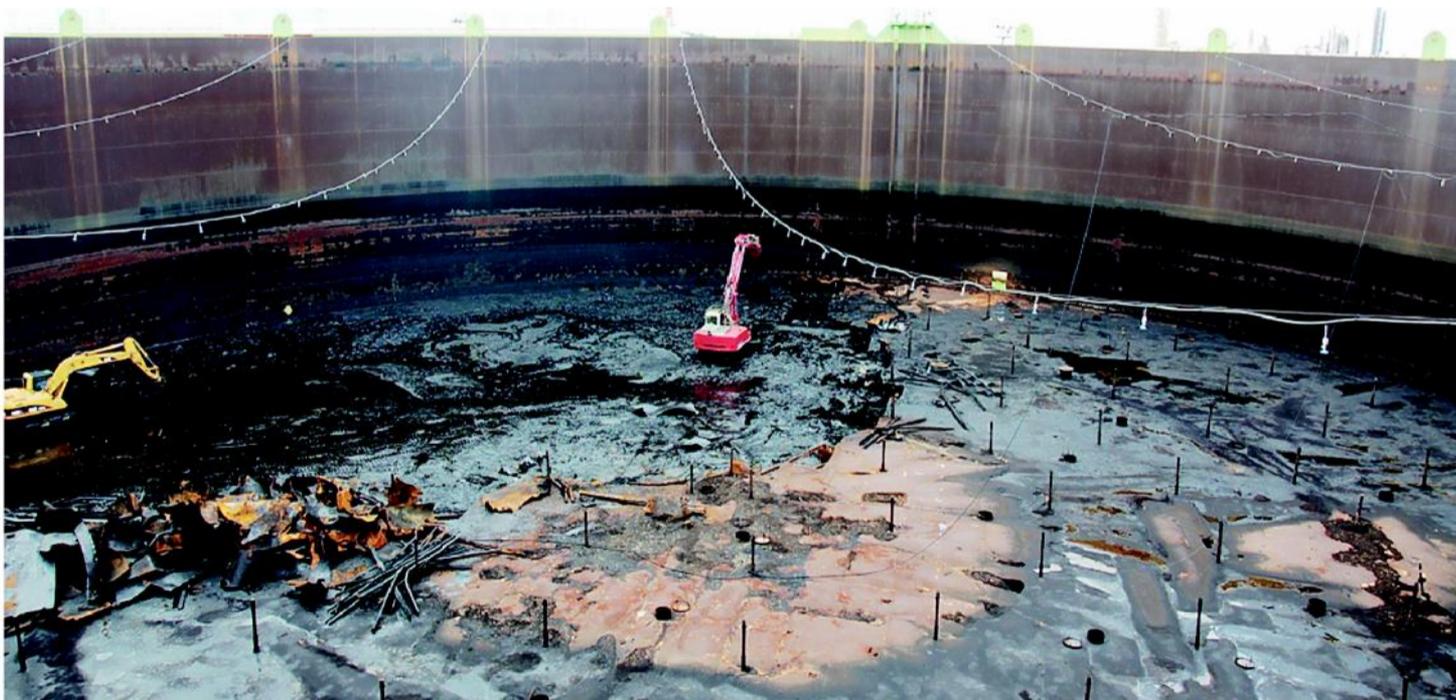
Work on demolishing the floating roof began on the 1st of October 2009 with the removal of the first compartments near the skin opening. Then, working closely with the reclamation company, we went on to remove the semi-solid materials, to demolish the roof and clean the scrap metal using high pressure jets.

The presence of heavy material that could not be pumped out of the tank without a special treatment beforehand made the digger's movements inside the tank awkward, in that this material sometimes reached a metre in height, covering the caterpillar tracks.

Only with the combined action of demolishing and then removing materials with small rubber spades was it possible to continue the demolition, making the parts of the floating roof that needed demolishing accessible.

The mechanical demolition phase was

completed in 45 days while the reclamation and cleaning phase continued for another 20 days. The speed of the work carried out, the low environmental impact and the proper safety levels maintained during the entire course of the operation proved the value of the project and the high technical and professional level of the staff that participated.
